Re: Clean Air Coalition Comment on Site Number: C915196B 1001 East Delavan Avenue Site
Brownfield Cleanup- Remedial Investigation Work Plan

The Clean Air Coalition respectfully submits the following comments regarding the Remedial Investigation Work Plan for Site Number C915196B: Brownfield Cleanup at the site formerly known as GM/American Axle and Manufacturing (GM/AAM), currently owned by East Delavan Properties (EDP).

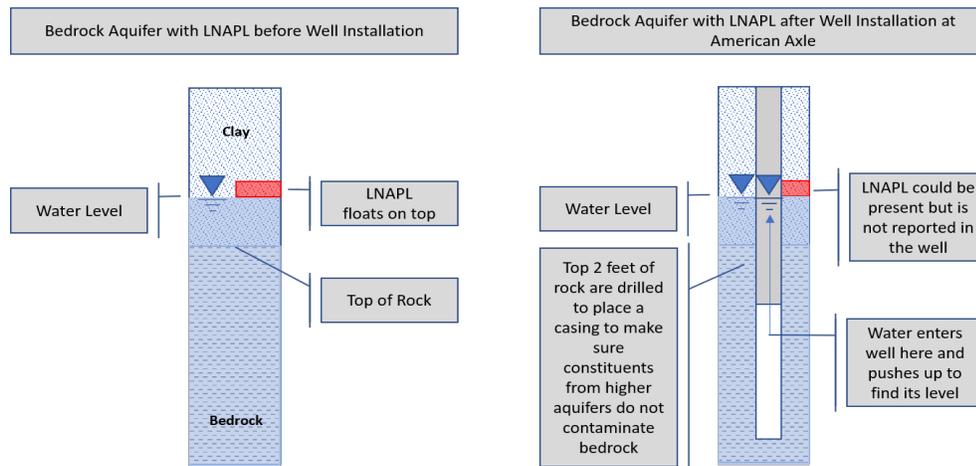
Analysis: Spatial stability of LNAPL is known to occur following source removal. Construction data from the logs of the historic bedrock wells referenced in the RIWP suggest that LNAPL measurements in these wells may not accurately reflect site conditions. Since LNAPL tends to float on water, wells must be open to the formation to be able to examine the surface of the water. Historic bedrock well construction at the BCP Site followed the conventional site investigation procedure of casing off the overburden and incompetent rock surface as normally used to test for dissolved constituents at depth. However, at the BCP Site, the potentiometric surface of water in bedrock was much higher than the open part of the well, as illustrated below:

As shown above, LNAPL collecting above bedrock cannot enter the well since the part of the well open to the formation is too deep. Well data from wells with logs and water level data included in the RIWP is presented below:

Analysis: Refer to Comment 7 above. Given the water levels generally found at the BCP Site, there is a strong likelihood that this casing will not allow the detection of LNAPL at the overburden/bedrock interface.
